REPORT OF THE BOARD OF INQUIRY INTO THE LOSS OF

HMS COVENTRY

25th MAY 1982

National archives DEFE 69/1336

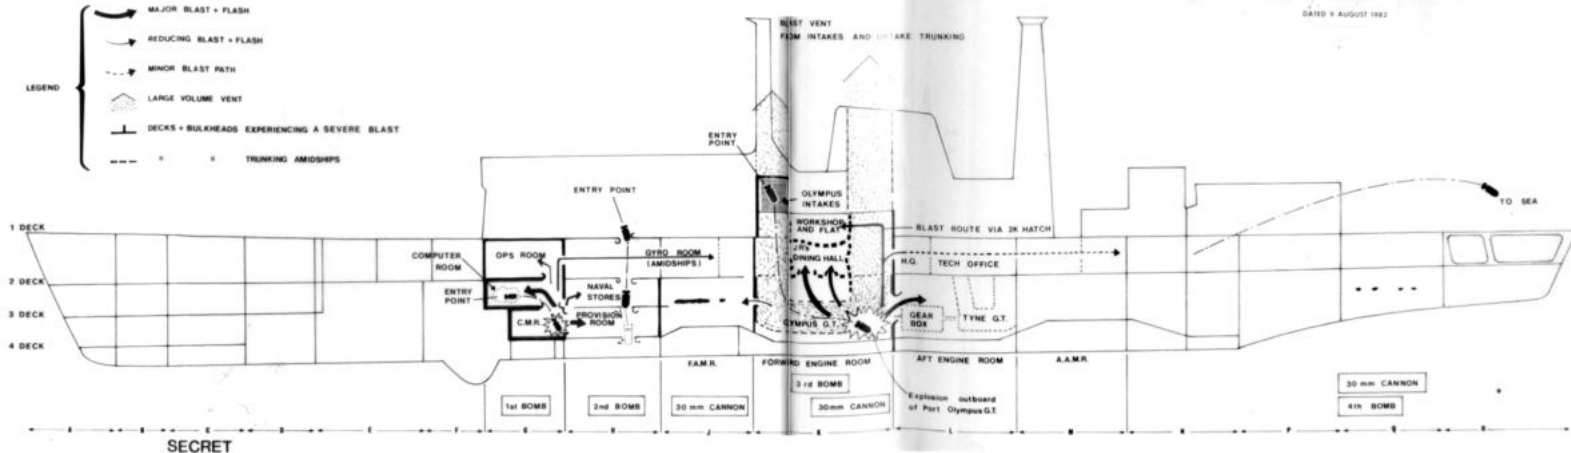
DIAGRAM No 1
BOMB* ENTRY AND BLAST ROUTE

79. The first bomb pierced the hull leaving a hole 6' long x 2' wide at 3G Port (Computer Room) and is believed to have exploded after delayed-action in the Conversion Machinery Room 4G blowing up the deck of the Computer Room and rupturing the 4G/4H bulkhead and ship's side. The fireball and blast from this explosion swept up into the Operations Room 2G from the Computer Room hatch 2/3G port. The Computer Room became a blazing inferno trapping and killing 7 men. Although the fire in the Computer Room was observed to subside, the generation of dense black smoke did not, thus forcing a total evacuation of all Operations Room personnel. This bomb put all weapon, sensors and communication systems out of action.

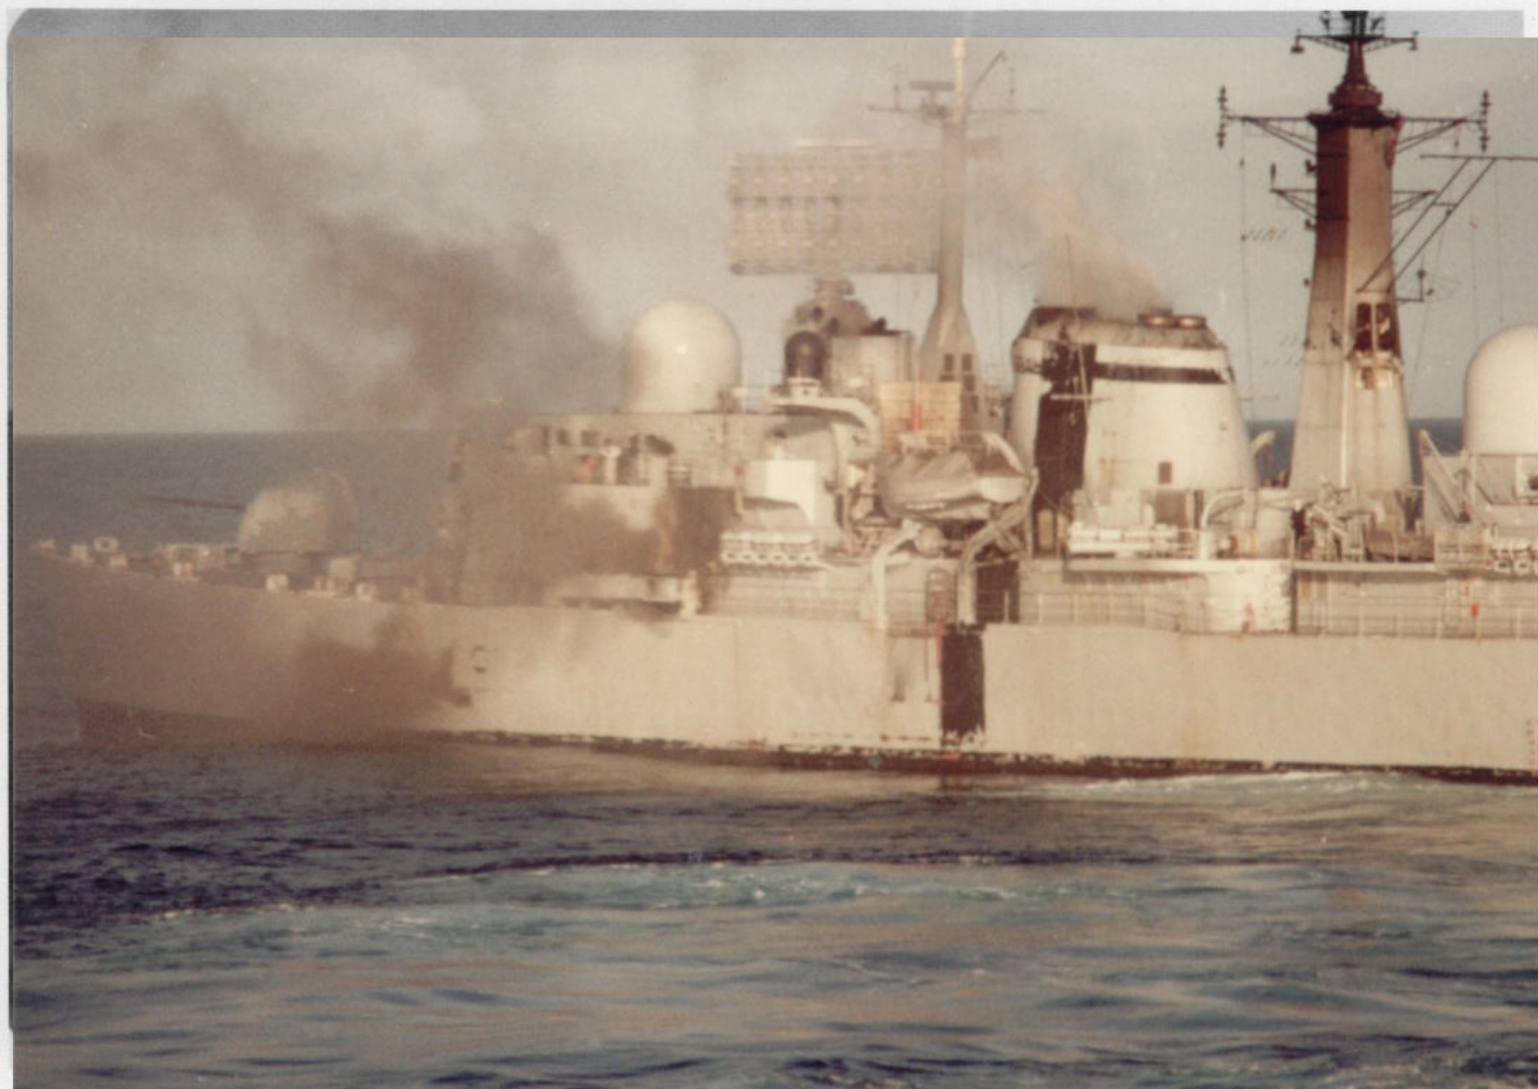
PLATE 2 - PORT SIDE UPRIGHT

76. 30mm cannon fire hit the ship's port side just above the waterline in 3J, the Forward Auxiliary Machinery Room (FAMR) and in 3K slightly higher than the Forward Engine Room (FER). (Annex F, Appendix 5, Plate 2). The watchkeeper in the FAMR sighted a horizontal slot 5' x 8" wide behind the port air conditioning plant. The shell(s) then entered the FER between the ship's side and the diesel service tanks through 3J/K bulkhead. The entry was not sighted but was confirmed later when a bomb blast in the FER vented a small fireball and debris into the FAMR. The FAMR was safely evacuated with both diesel generators left running, however this compartment flooded from the sea and the FER when the ship heeled to Port as a result of further bomb damage.

84. Photograph shows no apparent damage to K section hull plating on the Port side above the waterline except for two minor horizontal splits between 2 and 3 deck under the Cheverton davits. From the resulting heel to port immediately after this explosion, it is assumed that there was large scale underwater damage in K section, also with the port access hatch to the Engine Room blown out into 2 deck there was an irreversible loss of Watertight Integrity. In the Type 42 destroyer 2 deck passageway is subdivided into sections by doors for blast and smoke boundary protection, but there is no watertight integrity between sections due to the non-glanded passage of pipework outboard of the door frames. Examples of this problem can be seen at (Annex F Appendix 7 Plate 2).

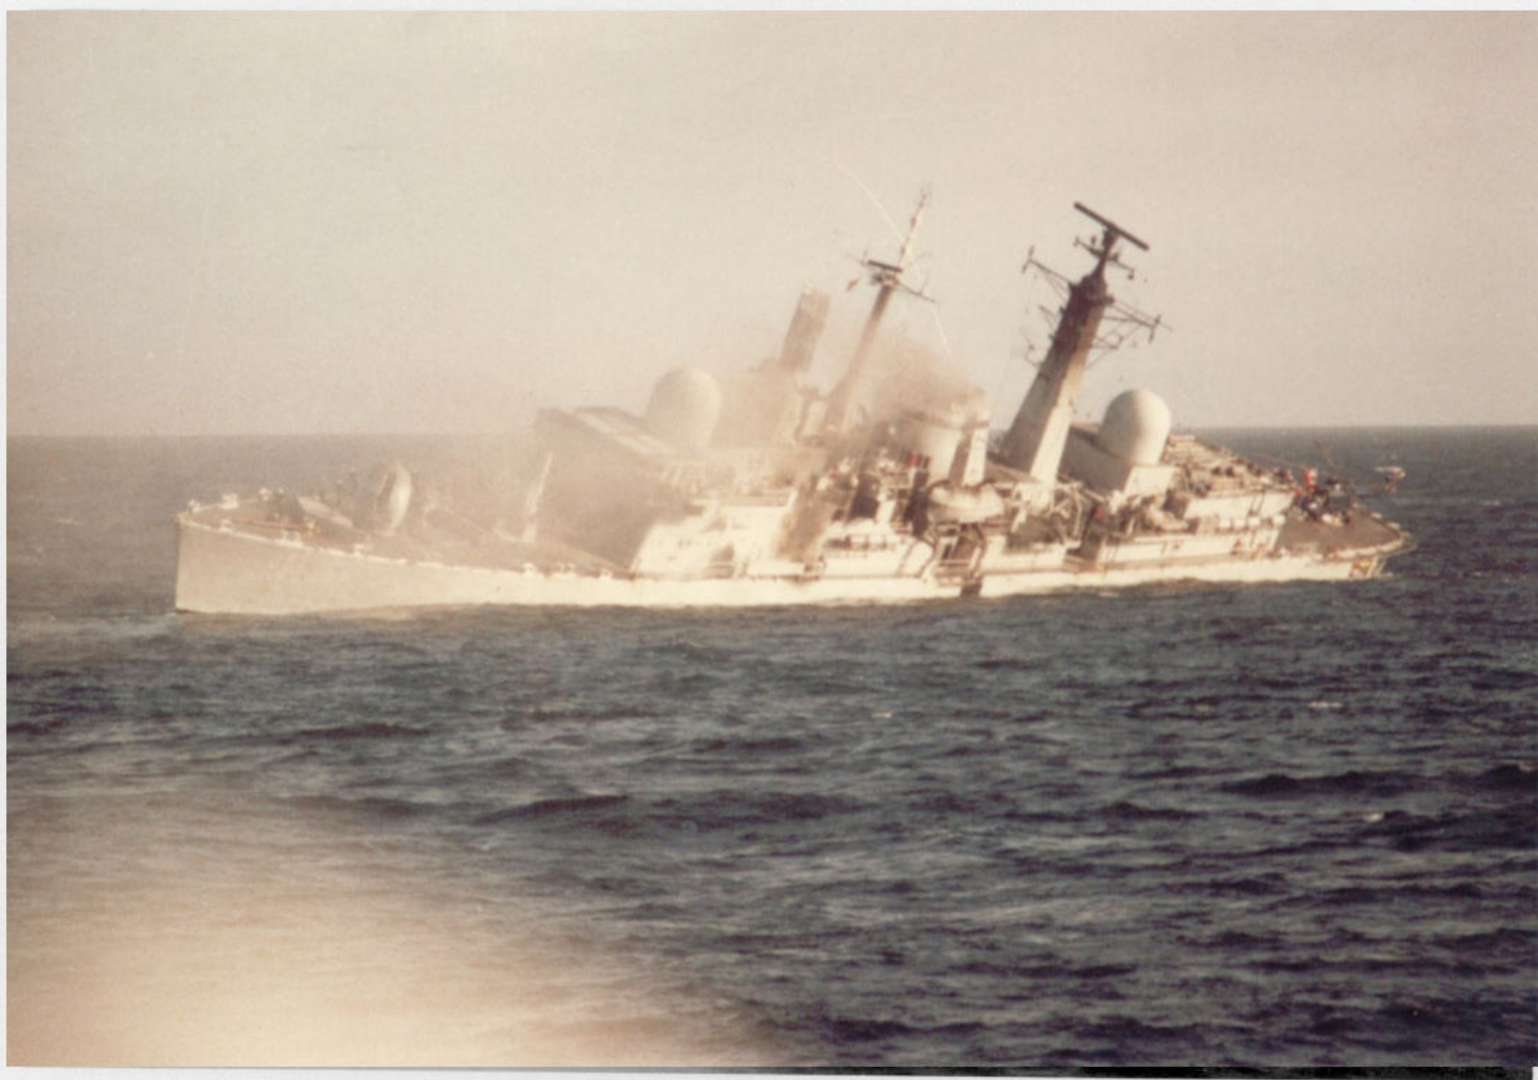
PLATE 3 - PORT SIDE HEELED

86. Within 10-15 minutes of the bombs exploding in the ship there was major flooding in G, H, J, K and L sections, the ship heeled to Port in the loll condition at about 15°. After 20-25 minutes the deck edge (heel now 25°) was immersed allowing the sea to enter 2 deck passageway from the second bomb hole in the Port waist at 1H and, at the same time, water was flooding 2 deck in K section from below via the blown hatch in the Forward Engine Room. The loll condition increased to 90° and the ship finally capsized and sank some time later.

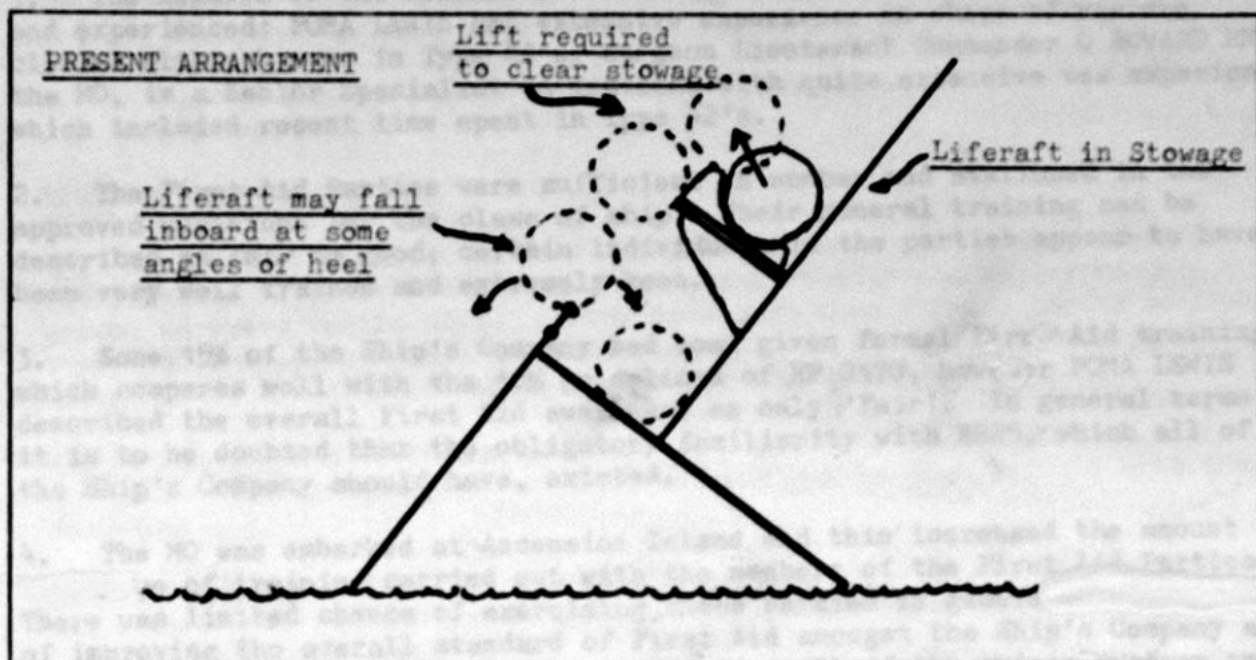
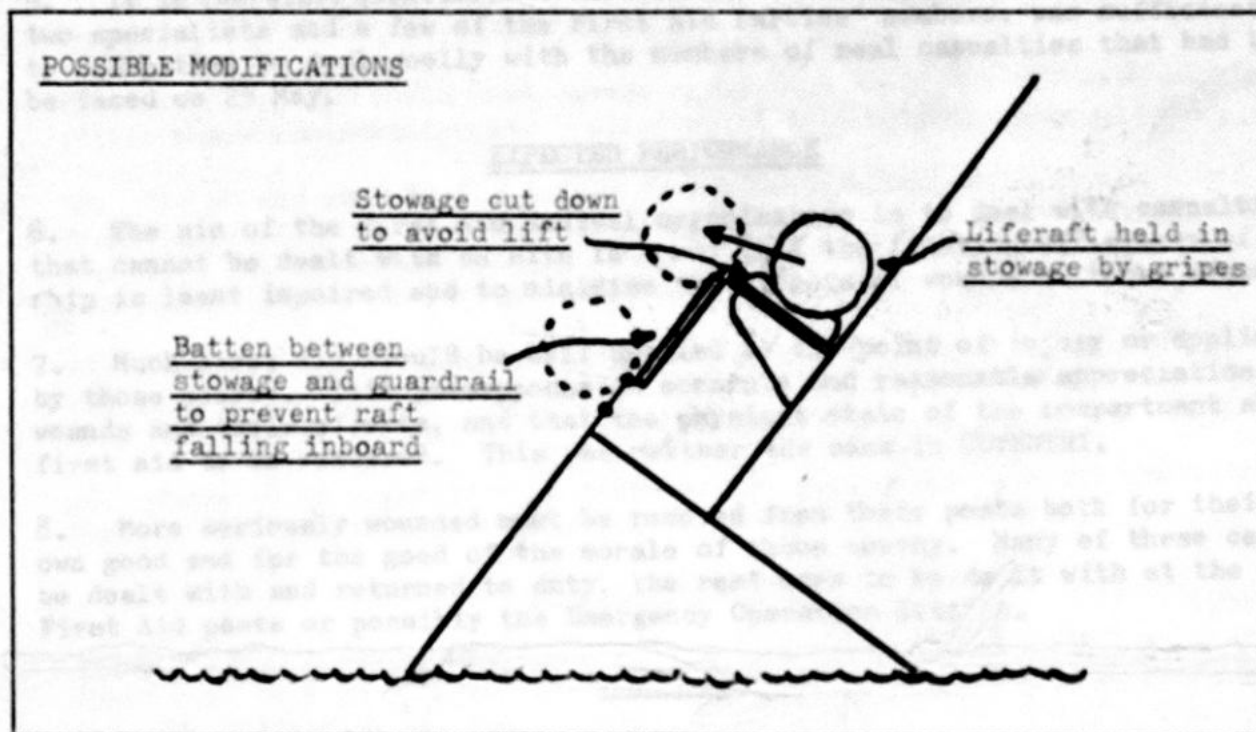
LIFERAFT LAUNCHING DIFFICULTIES

101. Men entered the rafts wherever they found them and, as a result, uneven loading took place. With only 8 rafts in the water some ended up seriously overcrowded with as many as 47 men counted in one raft (88% overload) and some men still outside in the water clinging to the grab ropes. There were considerable problems when attempts were made to propel laden liferafts away from the ship's side. Rafts from the after group eventually drifted astern and clear of the ship downwind. However some of the forward rafts drifted around the bow and back close under the port side, becoming entangled with obstructions as the ship steadily rolled over. One raft was eventually punctured by the antennae of an unfired Sea Dart missile still on the launcher and eventually sank causing the occupants to take to the water again.
