REPORT OF THE BOARD OF INQUIRY INTO THE LOSS OF

HMS COVENTRY

25th MAY 1982

National archives DEFE 69/1336

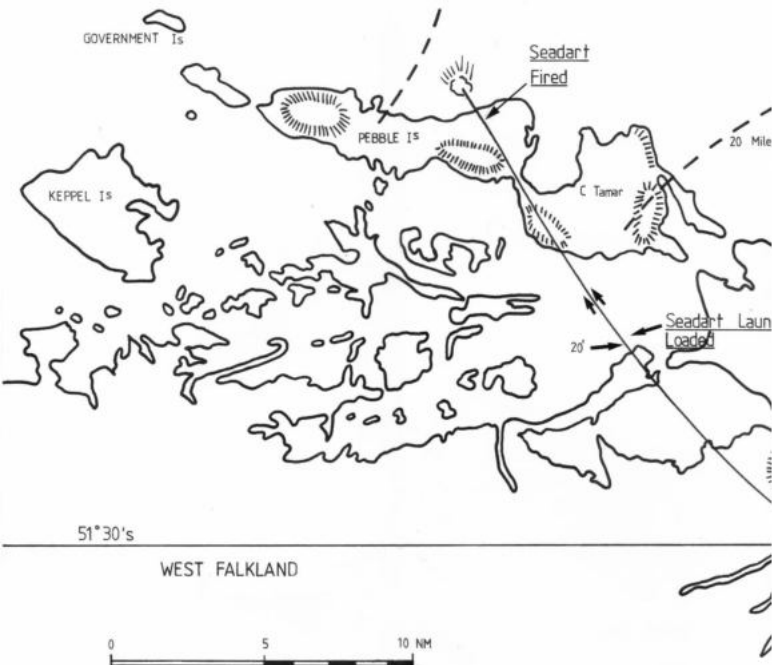
HMS COVENTRY / SEA DART ENGAGEMENT 1530 Z 25 MAY

Ship Turning To
Starboard During
Engagement
